Manhole Inspection Summary

Manhole # S25K__017MH

Insp Date: **7/7/09 11:37 AM**

Location Address: **S.Arlington St.**

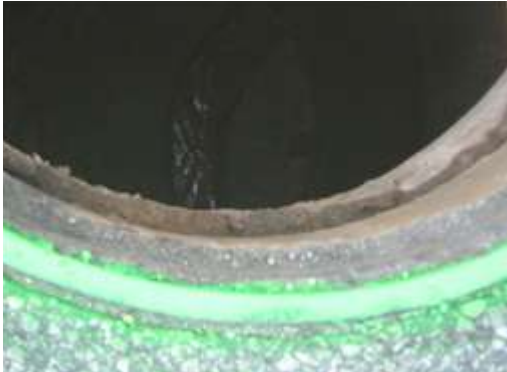
Defect 3

Frame Offset: **1** (in.) Condition: ☒ Sound ☐ Cracked ☐ Leaks

frame offset

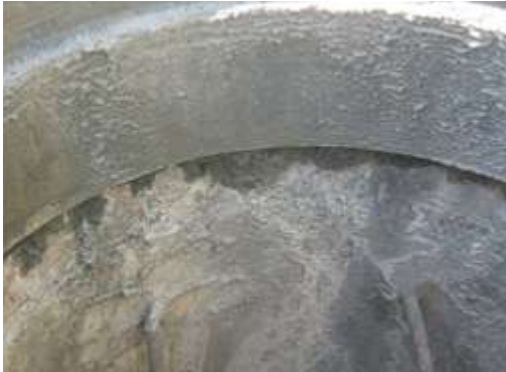
Defect 2

Infiltration: ☐ None ☒ **Joint** ☐ Cracks ☐ Mortar ☐ Roots ☐ Wall

infiltration at the frame/chimney joint

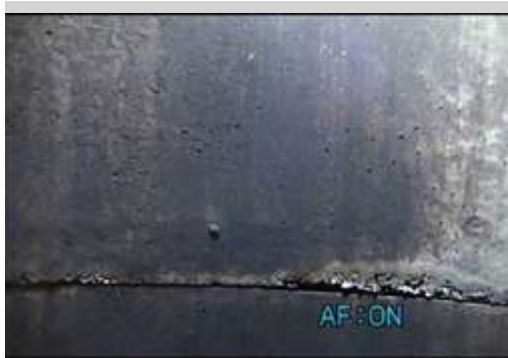
Defect 1

Infiltration: ☐ None ☒ **Joint** ☐ Cracks ☐ Mortar ☐ Roots ☐ Wall

infiltration at the corbel/barrel joint

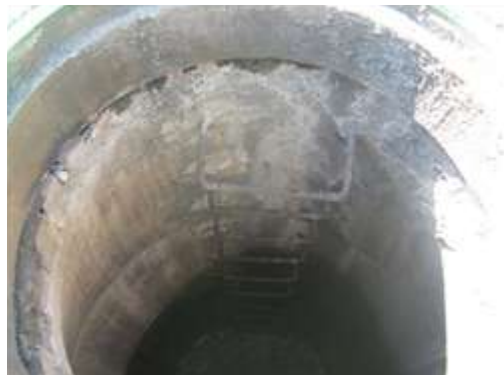
Defect 4

Steps Count: **10** Missing: **0** ☒ **Corroded**

corroded steps

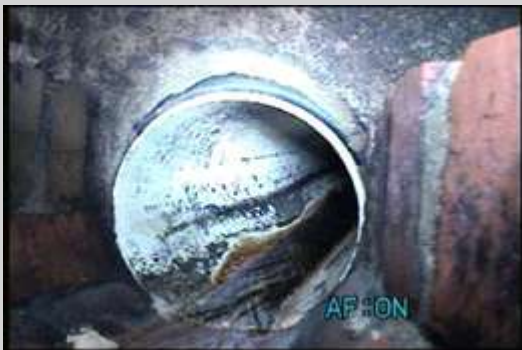
12 O'Clock Outflow

Pipe Height: **8.4** (in.) Rod and Bar (Angled)
Pipe Material: **PVC** ☐ Pipe Lined
Invert Depth: **12.82** (ft.) Flow Characteristics: **None**
Deposits: ☒ None ☐ Mud ☐ Sludge ☐ Debris ☐ Grease
Silt Depth: **0** (in.) Deposits Extent:
Infiltration: **None** Pipe Seal Cond: **Sound**

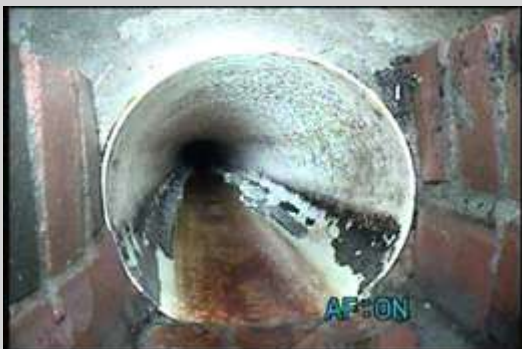
4 O'Clock Inflow

Pipe Height: **8.4** (in.) Rod and Bar (Angled)
Pipe Material: **PVC** ☐ Pipe Lined
Invert Depth: **12.66** (ft.) Flow Characteristics: **None**
Deposits: ☒ None ☐ Mud ☐ Sludge ☐ Debris ☐ Grease
Silt Depth: **0** (in.) Deposits Extent:
Infiltration: **None** Pipe Seal Cond: **Sound**
